**Date:** 22 January 2018

**Item:** Tram Overturning at Sandilands, Croydon on 9 November 2016 – RAIB and TfL Investigations – Update

- 1.4 The purpose of this paper is to summarise the Rail Accident Investigation Branch's (RAIB's) investigation into the Tram overturning and derailment at Sandilands on 9 November 2016. It also updates the Panel on the findings of TfL's independent investigation and shows progress to date against the recommendations arising from each investigation and measures introduced.

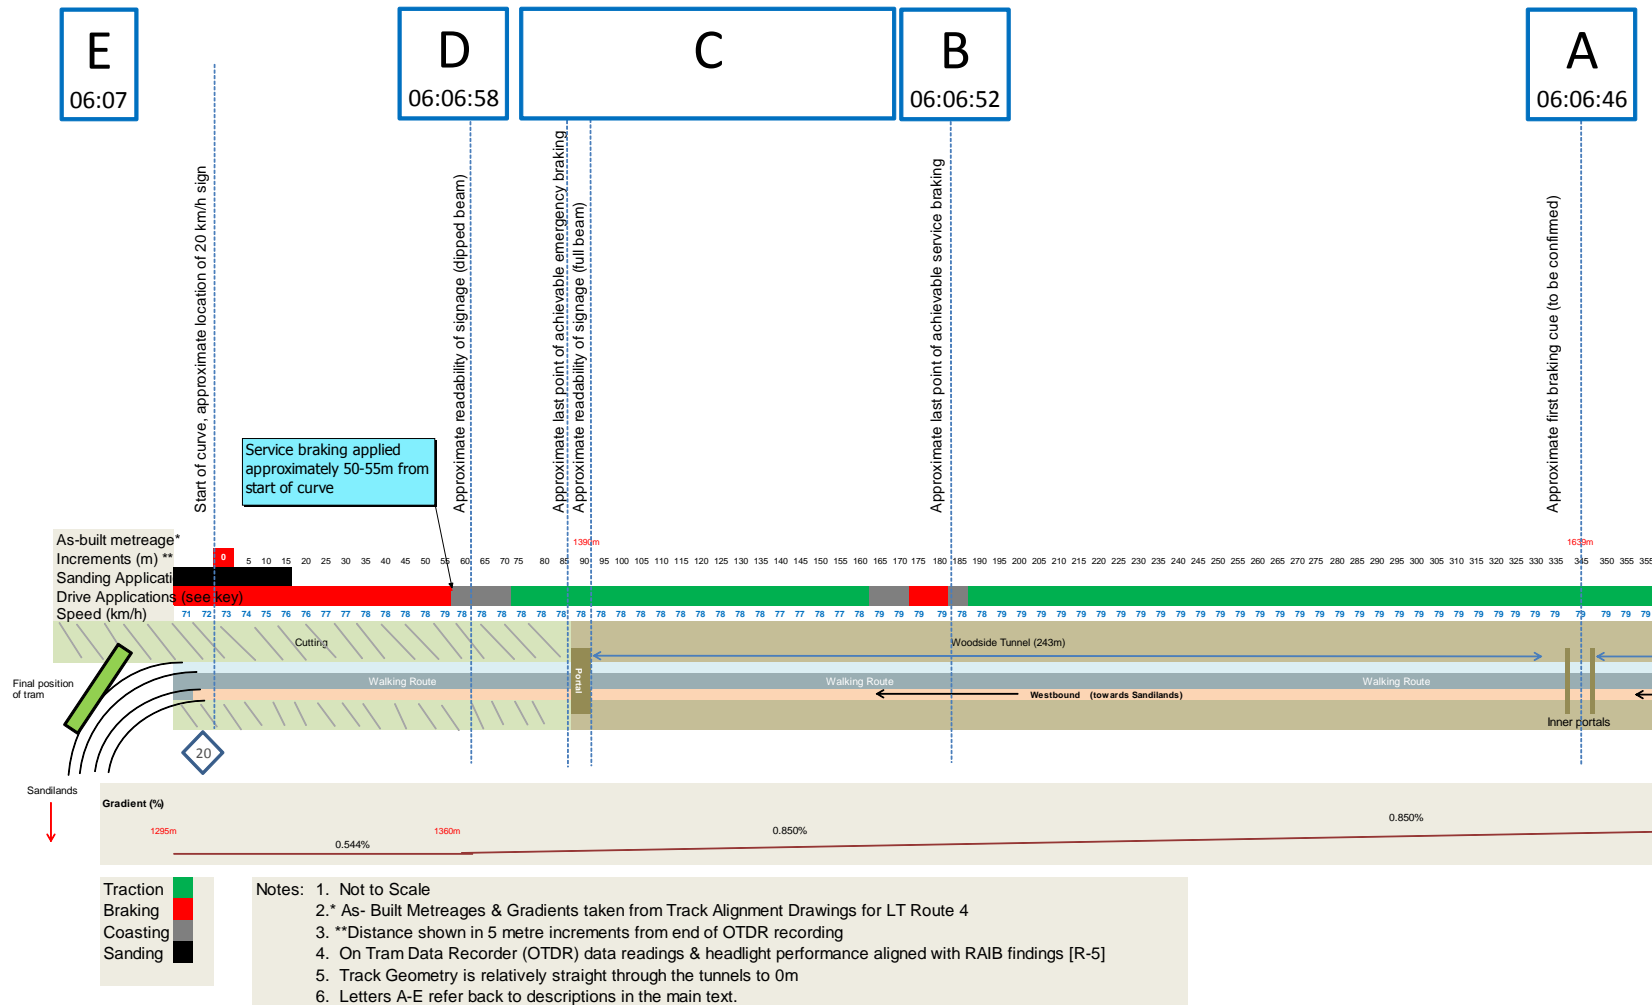
- 06:06:58 [denoted "D" on diagram] The tram braked, with a rate of retardation in line with that of a normal service braking applied by the driver (around  $1.3 \text{ ms}^{-2}$ ), with the sanding system being initiated (either automatically by the wheel slip/slide protection system, or manually by the driver) at 06:06:59 until 06:07:01.

Figure 4 - Extract of Appendix A Sequence of events (schematic) over final 15s/330m (approximation) before curve.

The braking cue point (nominally towards the start of the Woodside tunnel, see Appendix A and Figure 4 for details), can be ambiguous in certain environmental conditions and is therefore a contributory factor to this theoretical causal chain (see section on human factors below)
